Torsional Misalignment On Bag Filter Flanges Causes Expansion Joint Failure

Proper piping alignment is critical to an Expansion Joints life cycle

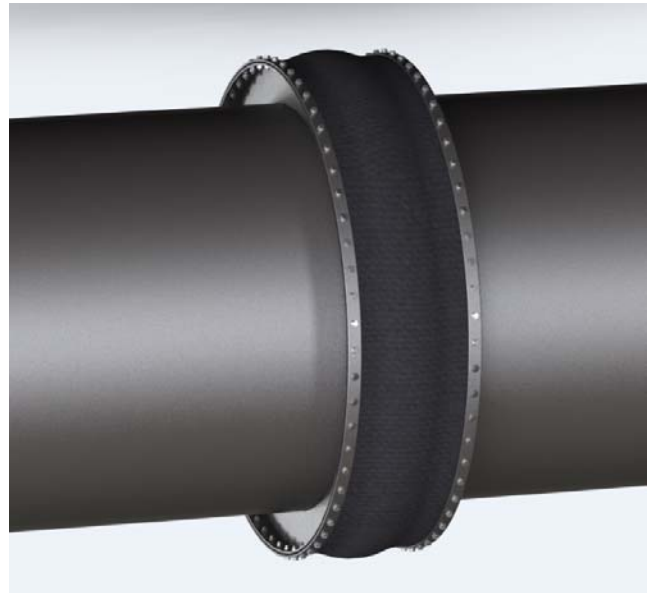
The outlet to the bag filter at Carbon Black Manufacturing Facility.

The existing flanges were misaligned creating a twist in the expansion joint during installation. This twist caused material to fold over on itself creating hot spots which lead to premature failure. Additionally the existing expansion joint was not designed to handle the operating temperature.

Holz Rubber Company supplied a HRPL7 to handle the high temperature. The end user was instructed that they should align their piping to ensure a proper life cycle of the expansion joint. Unfortunately, the facility could not align their piping until the next outage. Since the plant could not modify the piping the Holz engineering team worked with the plant engineering team to come up with an installation method to eliminate the twist.
