Custom Built Expansion Joints Solve Premature Failures Due to Piping Misalignment

Exceeding recommended misalignment causes multiple expansion joint failures costing down time and maintenance dollars

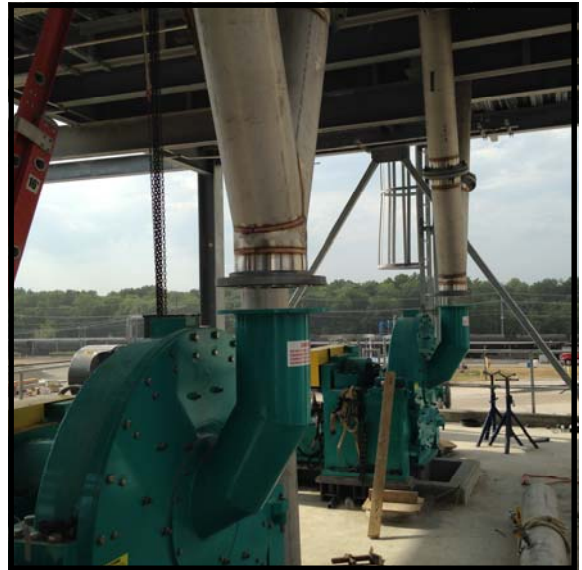
Piping to feed pipe on corn grinding mill at a dry grind ethanol facility. The dry grind ethanol facility produces fuel ethanol and Dried Distiller Grains (a low value animal feed product).

The process engineer was having difficulties identifying premature failures of the expansion joints on the grinding mills. Each expansion joint was failing after only 2 weeks of operation.

Holz Rubber Company determined the premature failure of the expansion joints was due to misalignment between the piping and the feed pipe on the grinding mill. Standard expansion joints are not designed to compensate for piping misalignment greater than 1/8". Misalignment reduces the movement capabilities of the expansion joint and can severely reduce service life due to excess stress. Holz custom manufactured an expansion joint with a built in 3/4" lateral offset to account for the misalignment; keeping the plant running.
