Incorrect Installation Leads to Leaking Expansion Joint at Children's Hospital

A leaking hot water pipe line in a children's hospital in southern California.

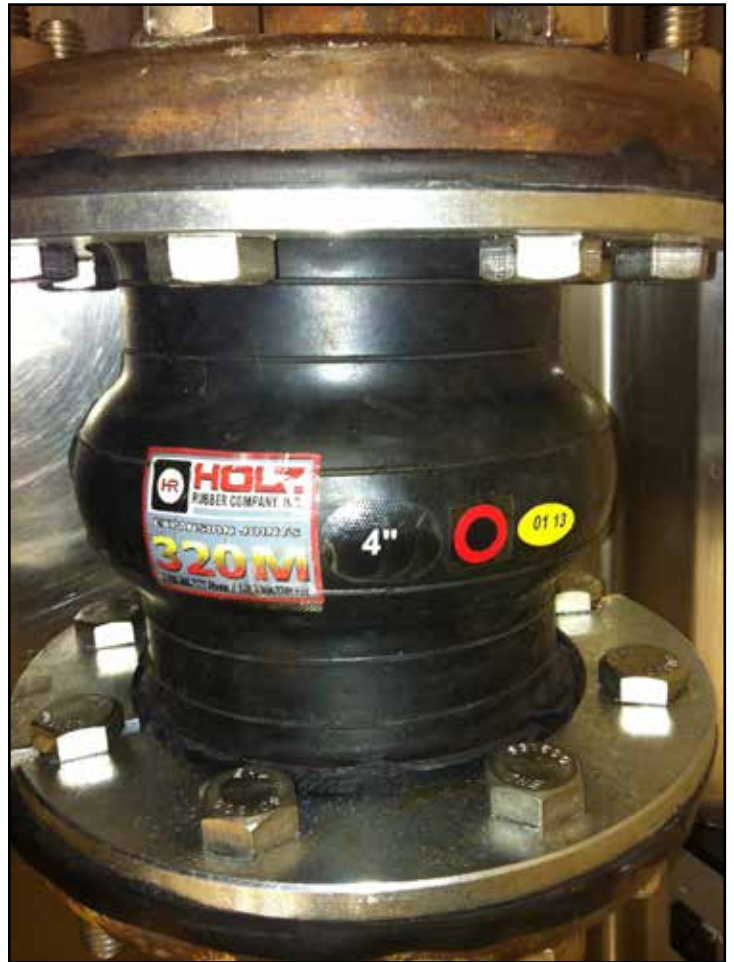
The Children's Hospital was struggling with an expansion joint leak at the flange connection. The leakage was affecting the availability of hot water in certain sections of the hospital.

A Holz representative evaluated the problem, and determined the expansion joint was installed incorrectly. During installation, the bolts used to connect the expansion joint to the pipe were over torqued causing excessive compression of the expansion joint flange. The over compression in turn caused the leakage to occur.

Holz shipped a new 320M to the hospital along with recommended torque settings. Once the new expansion joint was installed hot water began flowing accordingly.
