Settled Ground Causes Breach Opening to Widen at Coal Fired Power Plant

Holz Expansion Joint Replaced After 26 Years in Service

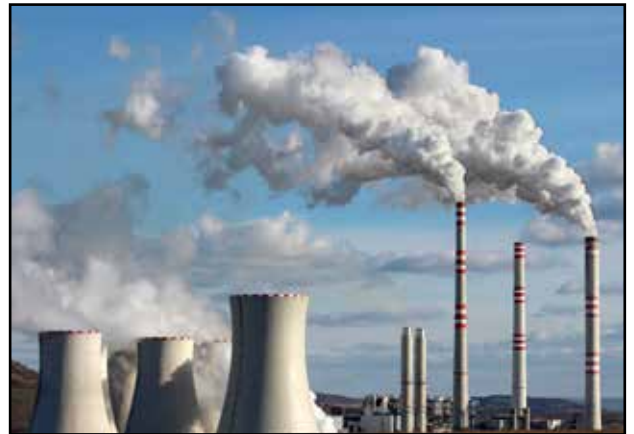
The customers' scrubber piping settled over the years which caused the breach opening to lengthen approximately 1 ¼" from the installed opening. This amount of additional opening caused the rubber to separate from the reinforcement ply on the outer cover of the expansion joint.

During a preventative maintenance period, the plant's team replaced the aged expansion joint with a new one before a failure occurred. The Holz team helped the customer by providing technical assistance and supplying the new high-quality expansion joints. Holz supplied the original expansion joint 26 years ago.
