Premature Failure of Unsupported Expansion Joint

Winery Process Piping Used To Transport Grape Juice and Solids.

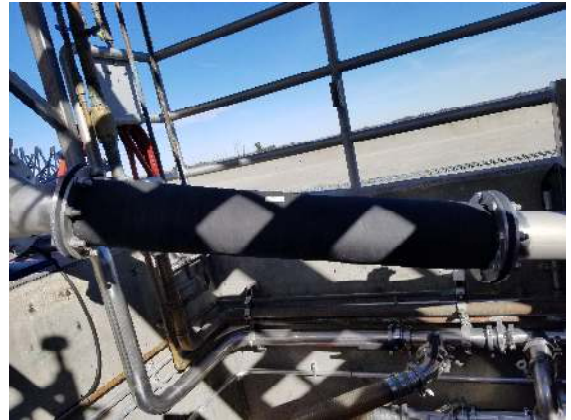
A winery experienced multiple premature failures of an Expansion Joint installed in its grape processing system. The Expansion Joint cover was tearing at the flanges, exposing reinforcement layers. The exposure raised a concern of possible contamination and complete failure. A combination of problems, including the length of the Expansion Joint, the system movements, and the weight of media inside the Expansion Joint, is causing the Expansion Joint to fail prematurely.
