## Design Changes Increase Service Life

A high velocity duct carrying dry powder.

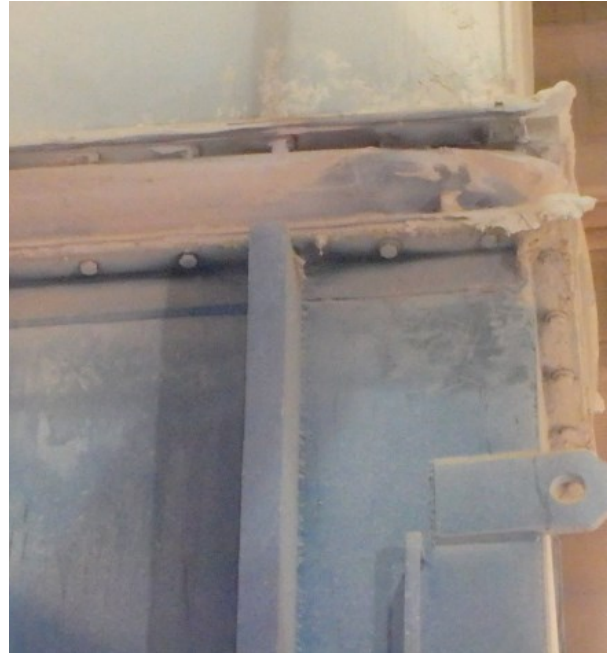
A fertilizer manufacturer had an expansion joint that started to leak one month after installation. Plant personnel observed media leaking through parts of the joints body, especially near the corners of the flanges.

A Holz Distributor that works with the fertilizer plant contacted us for suggestions of how to prevent the leaks and to increase the service life. There were two significant problems with the current design. First, the expansion joint frames did not include fasteners near the corners, causing the leaks along the edge of the flange. Second, the abrasive material was wearing the tube of the joint, causing it to fail quickly. After identifying the two issues, Holz Engineers designed a new flange configuration to eliminate leaking at the corners and proposed the addition of a flow liner to protect it from the abrasive material. Holz provided drawings and data to support the changes, and the customer decided to proceed with the new design. Due to the changes, the customer has reported a much longer service life and reliability in this application.
