Failed Expansion Joints Cause Unplanned Outages At Ethanol Plant

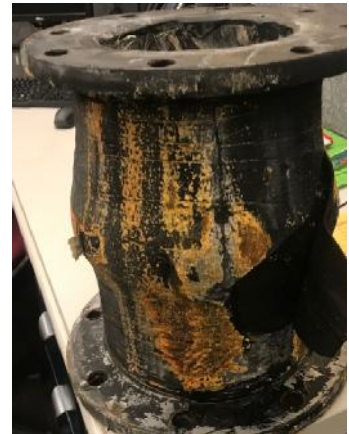
An ethanol facility had many expansion joint failures in their corn slurry lines. Due to the fact the slurry runs at a high velocity and is abrasive, the original expansion joints were not designed correctly and didn't last long enough for the customer. The abrasive slurry was causing the inside of the existing joint to wear away and expose the nylon reinforcement, eventually causing the joint to fail. These failures caused costly unplanned shutdowns while the customer replaced joints and cleaned up the hazardous area around the failure.

Our Engineering Group worked with our distributor and the plant to create a design to enhance the reliability and function of the expansion joint. We did this by making two significant changes to the existing design. The first was to include an abrasive resistant liner made from gum rubber, and the second was to change the arch style from wide open to a filled smooth bore to reduce turbulence.
