Expansion Joint Failure Due To Incorrect Dimensions

Fuel transport / distribution pipe line used in a Petro-Chemical production facility.

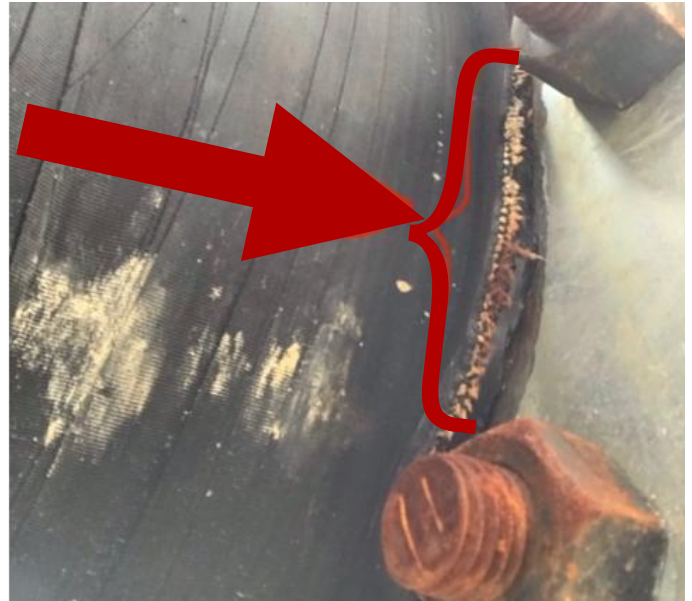
During a physical maintenance review of the expansion joints in the facility, the plant discovered an installed expansion joint with tears in the rubber flange cover, exposing the fabric reinforcement. The plant was concerned that the Expansion Joint could fail during operation, resulting in a potentially catastrophic accident or extended downtime.

A local Partner sent pictures and measurements of the installed Expansion Joint to our Engineers for review. We determined the pipe flanges had a lateral offset, and the Expansion Joint installed was stretched beyond the rated extension during installation. Our Engineers and Sales Team worked closely with the plant and distributor to get accurate measurements for the replacement Expansion Joint. We added three-quarters of an inch to the face to face and built in a seven-eighths offset to the Expansion Joint. The plant was very concerned about the Expansion Joints condition deteriorating further and opted to have us expedite the replacement joint. The replacement was installed within six business days with little downtime experienced by the plant.
