## Multiple Expansion Joint Problems Solved at a Wastewater Treatment Plant

Clarifier system at a wastewater treatment plant.

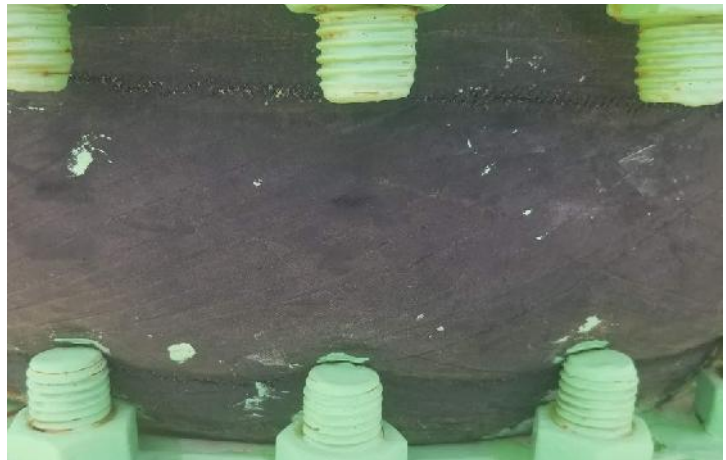
A wastewater treatment plant became concerned about the condition of their expansion joints connected to one of their

clarifiers. The expansion joints were delaminating and showing fabric reinforcement around the bellows. They reached out to a Holz Distributor to assist them in finding a long term solution that would eliminate these problems in the future.

Our Outside Field Representative and local Distributor traveled to the plant to evaluate the existing expansion joints. During the evaluation, they identified three significant issues. First, the expansion joints' covers were manufactured using a rubber compound that was not resistant to the outdoor UV light, causing them to delaminate. Second, during the initial installation, the hardware was installed backward allowing the threaded portion of the bolts to contact the body of the joints creating tears. Lastly, the piping system had settled over time, causing the flanges to become misaligned, further causing stress on the existing joints. Holz recommended replacing all of the problem joints with our 320 style engineered hand built joints. The new joints could be installed correctly and would be custom sized with offsets to fit the misalignments in the system. Also, they would include an EPDM cover that would prevent further deterioration from UV light.
