Incompatible Rubber Leads to Expansion Joint Failure

Application: Ventilation System Used With Oil Saturated Air In a Re-claimed Water Facility

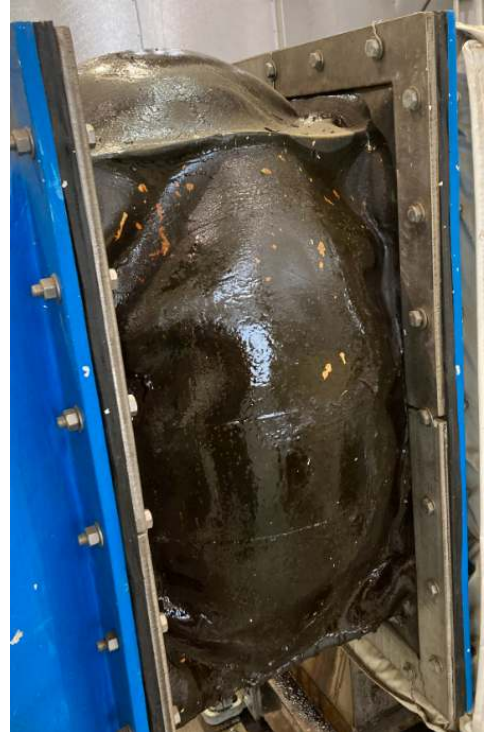
Problem: The Flue Duct Expansion Joint is leaking during operation. The tube or gas side tube material used to manufacture the current Expansion Joint is not compatible with the system media. The tube is failing under regular operation and is allowing oil to seep inside the body of the Expansion Joint, weakening its construction and allowing the body to swell. Oil saturation has continued to the point of weeping through the Expansion Joint cover and dripping on the floor below the Joint, creating a secondary hazardous condition.

Solution: Holz's Sales and Partner Distributor reviewed the system specifications, including pressure, temperature, and media type, to determine the correct rubber material to manufacture a long-lasting replacement Expansion Joint for this application. The oil in the system is petroleum-based which does not react well with specific elastomers commonly used in the manufacture of Expansion Joints. We determined that an Expansion Joint manufactured with a Nitrile Tube and Neoprene cover would be an excellent replacement for this application. Nitrile has excellent resistance to petroleum-based products, which will allow for extended maintenance-free service life. Proper Tube Material that won't deteriorate during use will also help solve the secondary hazard by keeping the media inside the joint rather than on it. Safety matters!
