Technical Knowhow Helps Power Plant Improve Turbine Performance

A gas turbine air inlet at a Midwest Power Generation Plant.

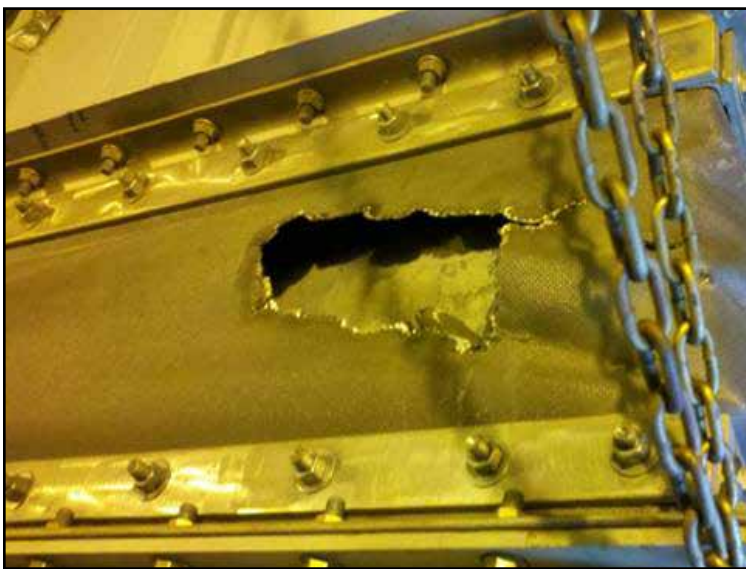
Before:

A Midwest power plant was struggling with a failing expansion joint. Cracks and tears close to the corners were causing a loss of air to the turbine during operation. This loss of air causes turbine efficiency related problems.

Holz suggested replacing the existing fiberglass reinforced expansion joint with a new Aramid reinforced expansion joint. This reinforcement is stronger and denser than the fiberglass and will provide for a longer service life in this application.
