# Hospital Saves Money and Improves Pond Pump Efficiency

### Duck Pond Settlement Shortened Life of Old Expansion Joint

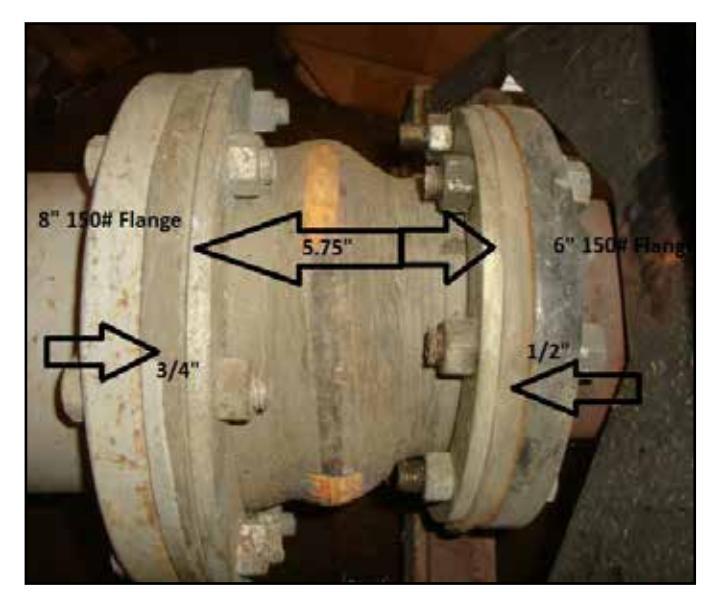
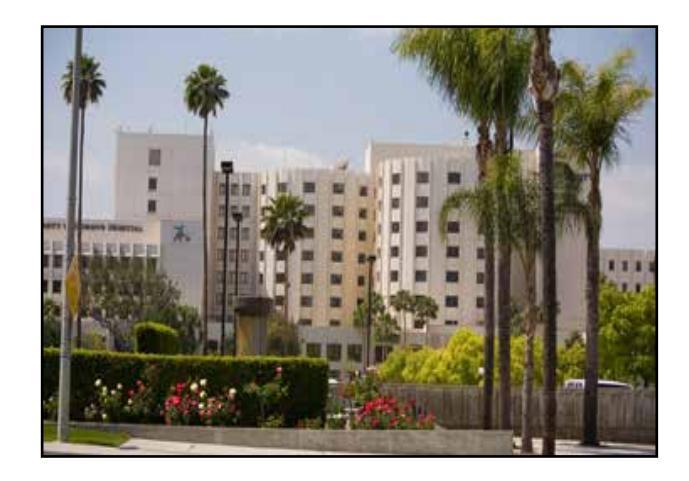
During scheduled maintenance, an inspection determined a leaking expansion joint between an 8" pipe and the suction side of a pump with a 6" connection. The original joint wasn't designed for pump settlement, and it was too short for the face to face dimension. Therefore, over time, the expansion joint stretched beyond its capabilities causing a leak.

The expansion joint was leaking at a pressure of three to five PSI. Even though the leak was

minimal at first, it created an extremely low efficiency level in the system. In due course, the leak would have caused the pump to work harder and wear out faster.

Since vacuum was a key factor on the suction side of the pump, the expansion joint needed a full vacuum rating of 30" HG. Additionally, the piping had settled over time, creating a misalignment. Holz designed and manufactured a custom sized tapered eccentric expansion joint to fit the "settled" piping. It was designed with thick flanges to ensure a leak proof seal. By correcting the leak early, the hospital improved the efficiency of the pump equipment and saved money by not having to replace the pump.
