HOLZ
RUBBER COMPANY, INC.

Application Data Sheet

Adding A Teflon Gas Barrier To The Composite Joint Eliminates Premature Failure

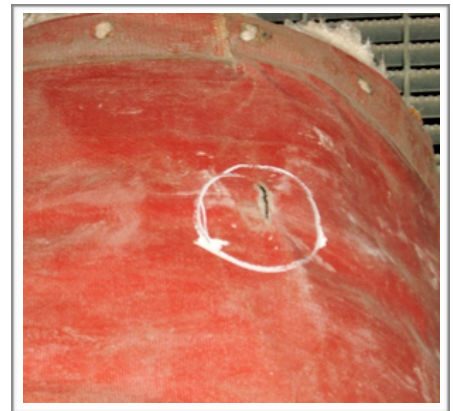
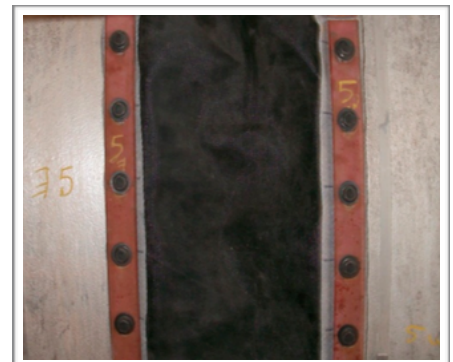
Problem: OEM expansion joints (fabricated by another company) consistently developed holes and leaks, even after repairs were made. The recently built plant went into un-planned outages several times to repair expansion joints.

Solution: The Holz Rubber Team provided replacement fabric expansion joints that were designed and constructed for the existing conditions, all while providing field support for the new installation at the customer's request.

The replacement fabric expansion joints solved the problems at the site and have allowed the customer to worry about more important things... like making money.
