Adding A Teflon Gas Barrier To The Composite Joint Eliminates Premature Failure

Application: Air Heater Air Outlet on a lignite fired 600MW CFB Boiler.

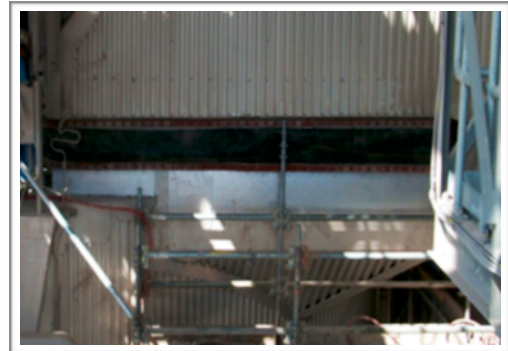
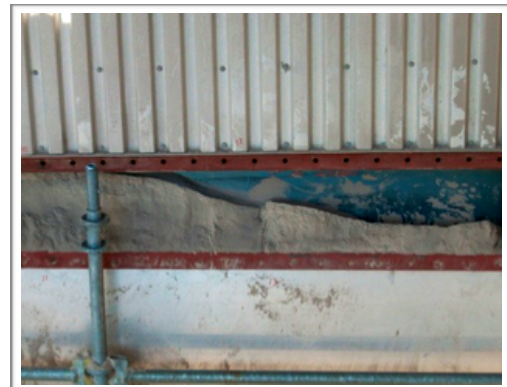
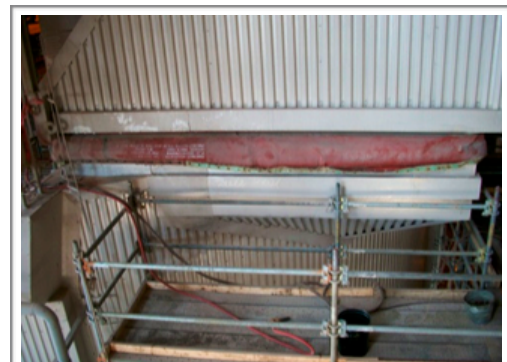
Problem: Often the primary air pushed through the heater baskets on the air heater outlet is considered to be “clean”. In reality, there is fine particulate that clings to the baskets and as the primary air passes through, it pushes the dust into the ducts downstream.

The dust collects in behind the flow liner and eventually packs in tight enough to rupture expansion joints. The original OEM supplier failed to recognize the potential hazards for this application, and the joint became the cause of several forced outages.

Solution: Holz immediately recognized the problem and replaced the joint with a design that eliminated the collection of dust in the cavity by utilizing a design with a full cavity pillow. The plant has not experienced any further issues at this location.
