Adding Reinforcement to a High-Temp Expansion Joint Improves Reliability

Process air ducting expansion joint in a chemical plant.

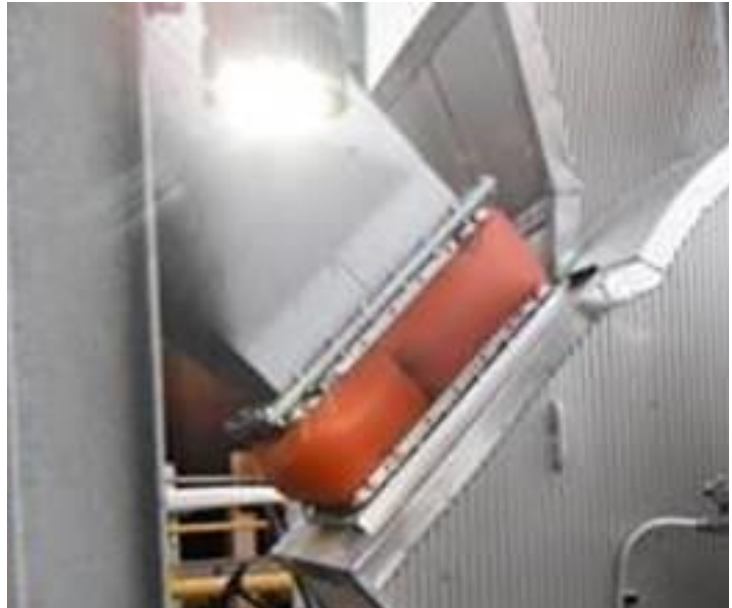
A Chemical Processing Plant reached out to a Holz Distributor regarding a leaking High-Temperature Expansion Joint that they discovered during an inspection. One of the belt style Expansion Joints was filling with air like a balloon, and the splice was beginning to tear. The

Holz reviewed the pictures and specifications provided by the plant and determined that the existing Expansion Joint was made of a non-reinforced material and supplied with an overlap cold splice. The lack of reinforcement material allowed the installed joint to balloon outward and cause additional stress to the already weak splice. Holz Engineering recommended replacing the failing joint with an endless High-Temp EPDM belt with fiberglass reinforcements. Replacing the existing High-Temperature Expansion Joint with an engineered solution eliminated a forced outage due to a poorly designed and spliced Expansion Joint.
