Engineering Solutions Helps Chemical Plant to Run Leak Free

Air supply fan connection in a chemical plant.

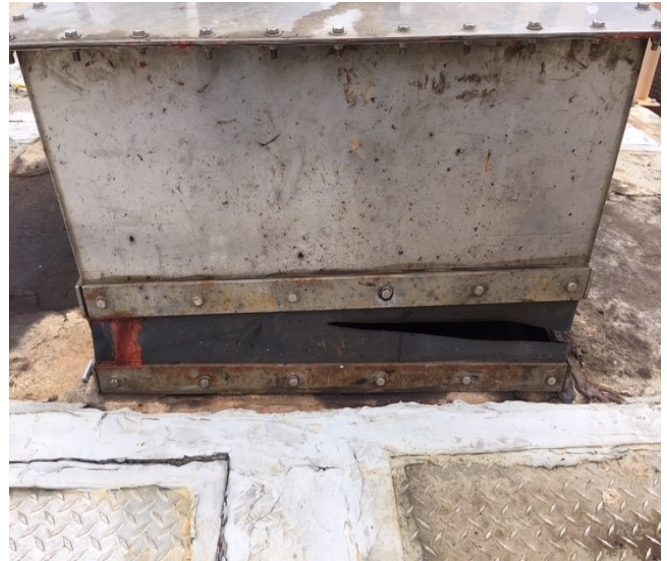
A routine inspection a chemical plant found a tear in one of the expansion joints on their air handling system. Typically when an expansion joint tears it is a sign that the system has moved beyond the designed extension limit of the expansion joint. It is critical the system operates without leaking. The facility decided to replace the expansion joint immediately.

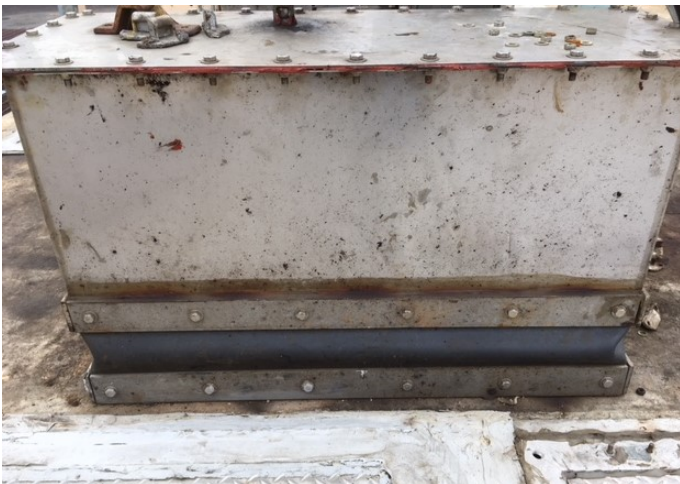
A Holz distributor who had been working with this facility contacted Holz to design a solution that would perform better than the current configuration. Holz developed a solution using their 945 style designed to allow much more significant movement than the joint that had torn open. The 945 design is a fully molded expansion joint with a bellows in the body of the joint that allows maximum movement without stressing the system. Our Engineered solution helped the plant to get running again and will ensure safe and leak-free operation.
