Equipment Damage Causes Unscheduled Outage And Emergency Repairs

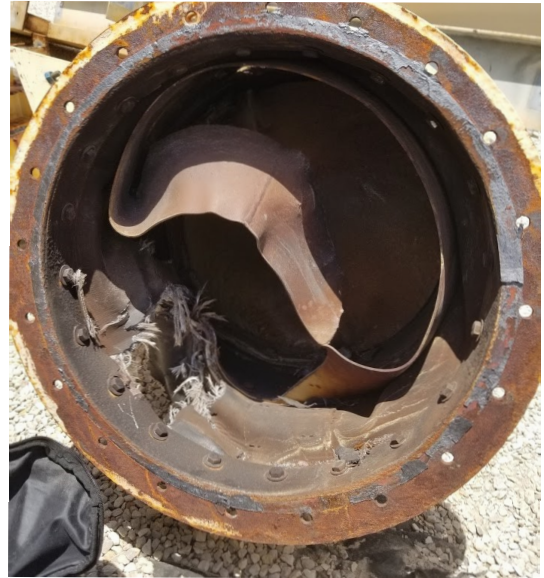
During normal operations at a combined cycle power plant one of these supply fans broke apart and caused a catastrophic damage to three different expansion joints. The force of the blades also destroyed ductwork and flow liners that were in the system. If the equipment offline no power can be generated so the plant was eager to get the repair expedited. Additionally, the plant found they did not have adequate drawings on file, so the damaged equipment would need to be measured in place to produce new parts.

Working with a partner distributor, a Holz representative traveled to the site to measure and make recommendations to replace the damaged joints. The joints were found to be an odd size with a non-standard bolt pattern. The Holz engineering team was able to expedite the order in time to meet the deadline. The plant was able to get the unit back up and generating electricity and profits.
