## Adding an Expansion Joint Results In Reduced Noise and Equipment Damage

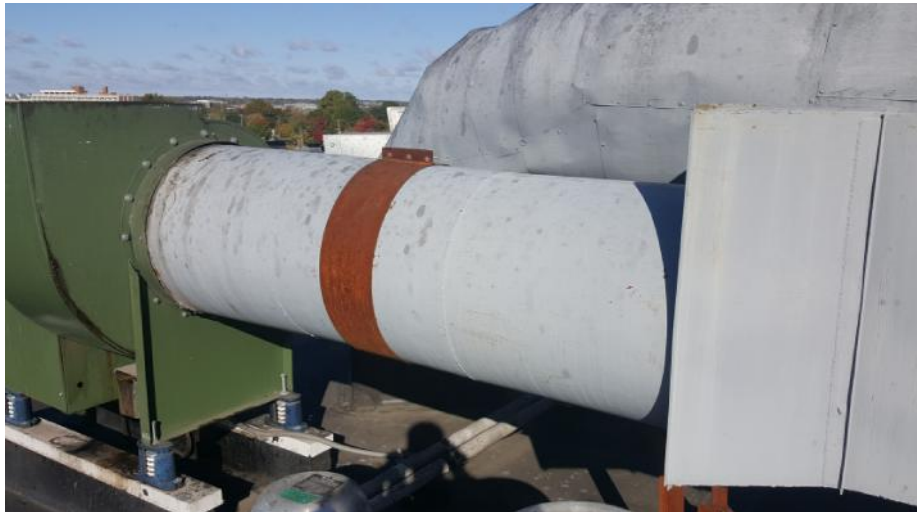
This restaurant had problems with noise and vibration from their exhaust fan and contacted our distributor in the area to come up with a solution. When the exhaust ductwork was initially designed, the fan was connected directly to the building with a rigid metal duct. Because the duct is stiff, it was transferring fan vibration directly to the restaurant causing damage and noise inside the building.

The ductwork before the expansion joint was installed

The distributor called Holz Rubber to help them design an expansion joint to install in the ductwork between the building and the exhaust fan. Our Engineering Group designed a sleeve type joint to install by banding it in place effortlessly. The solution worked by isolating the fan from the building to reduce vibration and the likelihood of equipment damage. Also, without the vibration traveling along the ductwork, there is a noticeable reduction of fan noise in the building.
