## Unforeseen Problems After Equipment Upgrade

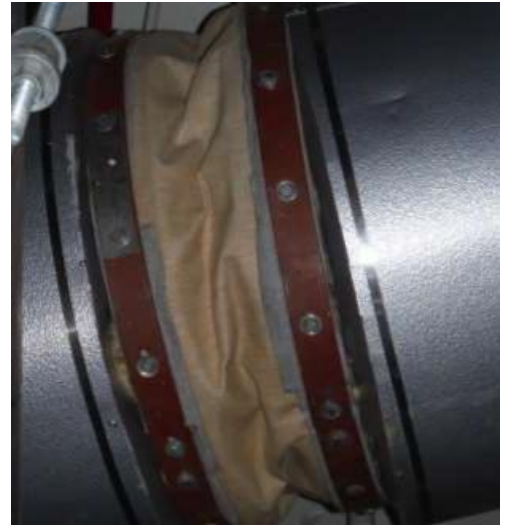
A Customer came to Holz Rubber shortly after replacing their outdated boiler system and ductwork. They had an old expansion joint that had been part of the old boiler that was not a proper fit for the new ductwork. The breach opening between ducts was shorter than the original design, and the duct was misaligned, causing it to stretch axially and laterally. This misalignment was causing hotspots in the high temp joint material causing the maintenance personnel to doubt the joints' ability to safely function.

A Holz Rubber expansion joint product specialist reviewed all of the information available for the entire system, focusing on the problem connection. Holz engineered a fully molded -945-S-W- style arch sleeve flue duct joint to meet the dimension, temperature and movement requirements of the system. When designing and installing any new equipment, it is essential to identify any potential problems in the entire system to ensure all of the components function safely and reliably based on their intended use.
