A Metal Bellow is Replaced with a Molded Flange High Temperature Composite Expansion Joint

Lime Kiln Dryer Process Air fan connector at Pulp and Paper Mill.

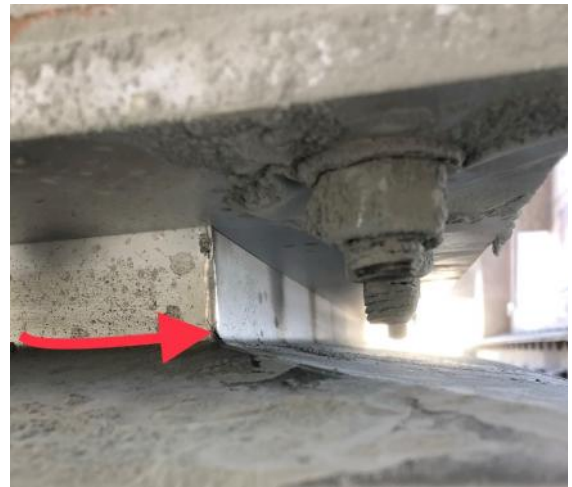
The Paper mill noticed a ten + year-old metal bellow had failed. They replaced the existing bellow with the same design. Three months after replacement, the joint failed again, showing stress cracks at the welds, where the bellows meet the flat. The movements are too great for the mitered and welded seams of the metal bellow. This plant system requires seven days a week operation for 12-18 months continuously. The unexpected failure and downtime left the mill open to exploring a non-metallic expansion joint viable option.

Our Engineers reviewed the system specifications and pictures provided by our Distributor of the application, including the failed metal bellow. Based on the system movements, operating temperature, and media, our engineers recommended a Molded Flange Single Layer Composite PTFE/Fiberglass expansion joint incorporating 1/2" Radius corners for strength and stability during operation. We also designed a metal flow liner to fit inside and protect the High Temp Expansion Joint material from abrasion. The new design replaced the existing failed metal bellow, bolting to existing flanges with no need for additional frames or onsite fabrication. The light weight of the High-Temp Joint saved time and money compared to installing a metal bellow.
