High Temperature Expansion Joints Keep Ice Breaker Moving.

A turbine exhaust ducting system on an ice-breaking ship. The turbine exhaust ducting system recovers unused gases from the cylinders and is directed to the exhaust gas boiler to recover most of the wasted energy.

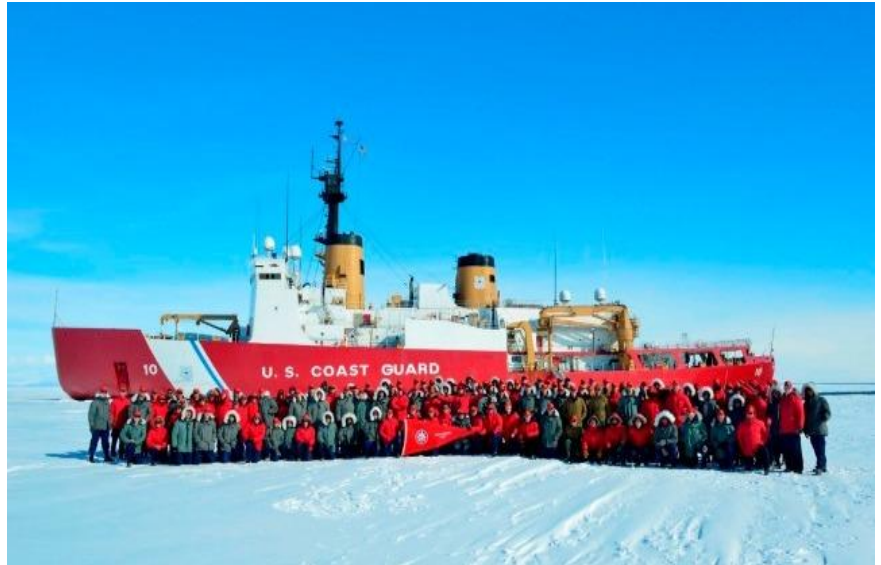
The High Temp Expansion Joints installed on the ship's Turbine Engine Exhaust were damaged and failing during a scheduled maintenance cycle. The damaged High-Temperature Composite Expansion Joints allowed hot turbine exhaust gases to enter the vessel interior, creating a scorching, hazardous work environment.

The contractor in charge of the repair contacted Holz rubber with an urgent request to replace the (3) High Temp Expansion Composite Joints before the ship's scheduled departure date. Our Sales and Engineering team reviewed the system requirements and pictures of the installed joints. Based on the system specifications provided, Holz Rubber suggested a robust Multi-Layer composite belt design wrapped with stainless steel wire mesh for added protection of the belt during operation from any particles found in the exhaust stream and the 1,100° sustained temperature. Our High Temp Multi-Layer Composite Expansion joints were manufactured ahead of schedule and installed by the contractor allowing the ship to return to cutting ice, paving the way in the North Pole.
