Wrong Fabric Material Caused Suction Leak in PVC Plant's Boiler Blower

Lower Cost Materials Doesn't Equate to Cost Savings

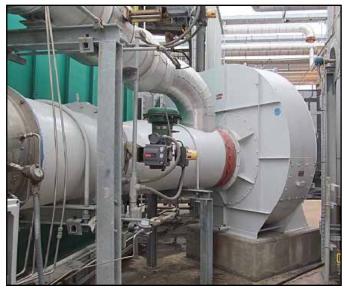
A suction leak on the boiler blower's air inlet expansion joint was created when the expansion joint was pulled into the duct stream and tore from rubbing against the ductwork. The original joint was made of non-laminated Teflon[®], which in this situation, is the incorrect material

choice. A boiler blower air inlet operates under negative pressure, therefore the material chosen isn't strong enough for this application. Although this material is lower in price than other materials, it collapses under vacuum and punctures easily because it is very thin. The tear caused cold air to leak into the boiler blower, and dramatically reduced the efficiency of the boiler costing the operator money.

The air enters the boiler preheated at approximately 320°F. The negative pressure is 83" in W.C. (water column). The temperature and negative pressure are primary concerns when choosing the correct expansion joint. For this application, Viton[®] is a better material option because of its rigged strength.

Under a negative pressure situation, the supplied Viton expansion joint won't be pulled into the ducting system because of its strength and it was installed with a very short breach opening. Holz provided a 1/8" Viton expansion joint with fiberglass reinforcement. The expansion joint was secured in place using Viton caulking with band clamps. When choosing the right expansion joint, material type is a critical component for longevity and

effectiveness. Although the Viton is a bit more expensive, the life cycle of the joint is significantly increased, making it a cost saving purchase.
