Incompatible materials and design cause failure at potato processing facility.

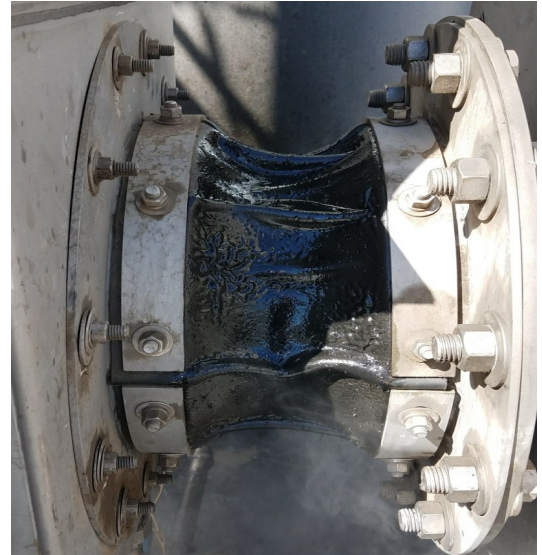
Holz received a call from a distributor asking about the availability of an expansion joint that was needed in a hurry. They said that one of their customers replaced a joint 48 hours earlier and it was already starting to fail. During inspection, the newly installed joint looked like it was delaminating and the rubber was softening due to heat or chemical attack. Also, the system was exposed to significant vacuum pressure that caused the joint to collapse.

Due to the high temperatures and chemicals in these conditions, Holz recommended their HRPL7 material as an ideal choice. The HRPL7 is rated for high temperatures in wet locations and is rated excellent for resistance to the chemicals used at this facility. At last report, the customer was very happy with the performance of this product and will use it in other applications in the future.
