## Redesign Helps Power Plant Run Leak Free

A 72" water circulation system in a coal fired power plant

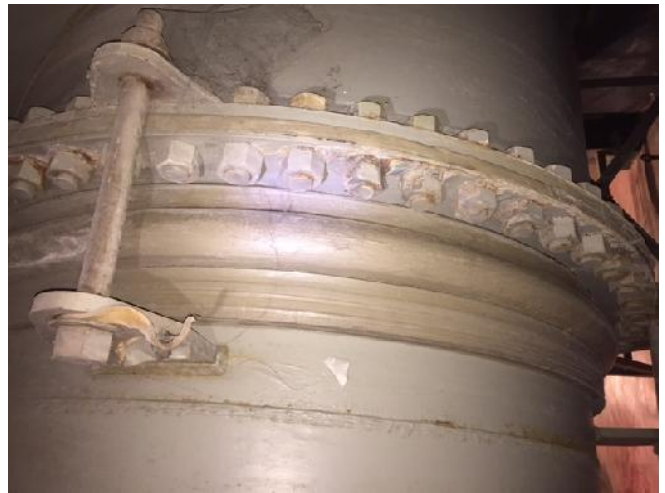
Holz was contacted by a partner distributor that needed an engineered solution to replace two circulating water expansion joints that had been in service since the 1960s. The existing joints were unique since one side of each was vulcanized to the pipe instead of using flanges.

Our distributor and engineering team worked with the plant engineers to find a way to design joints with an industry standard. The decision was made to cut the pipe on the side that was vulcanized and replace them with standard ANSI flanges. This innovative solution made it possible for Holz to engineer 320 style EPDM joints with 150# integral flanges for easy and a cost savings installation. This solution is now in service and will keep the plant running leak free for many years.
