Hot Air in a Grain Facility

Application:
**Hot Air Ducting Used In The Grain
Processing Industry**

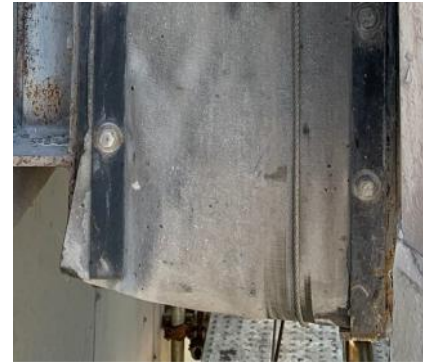
A grain processor contacted a Holz distributor to request a new belt-type expansion joint. The current expansion joint had been in service for eight years. The belt was cracked, split, and not sealing well due to age and an offset of the mounting flanges. The installed frame used 90° corners and was not clamped correctly. The sealing issue was causing damage to the inside of the belt and inefficiency in the air system.

Our Engineering team reviewed the application and dimensions provided by our distributor. We recommended a new weld in inward angle frame design incorporating radius corners to help eliminate potential damage during operation. We also added an integral flow liner to keep the process air moving to eliminate belt flutter and radius backing bars to further seal and promote the highest system efficiency possible during operation. The belt elastomer is Viton due to the temperature exceeding 350 degrees.
