Overhead Leak Damages Expansion Joint

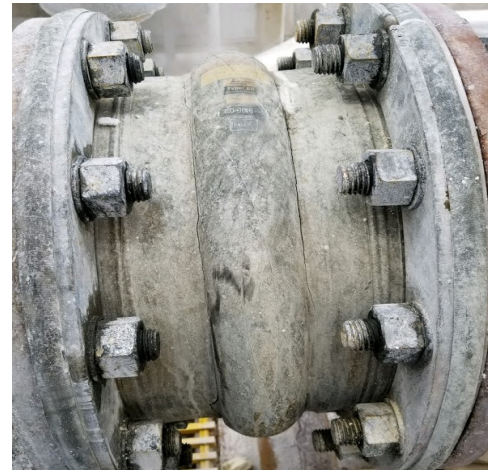
A distributor was concerned the cover (outer layer) of some of their expansion joints were delaminating. A Holz technical representative traveled to the plant with our distributor to troubleshoot. During the inspection, he found that the expansion joints had a layer of caustic on them from a leaking pipe overhead. The expansion joints did not have a cover that was chemically resistant; the joint was delaminating and cracking.

Holz's engineering team made recommendations to help the customer fix this problem and to prevent it in the future. First, we recommended that the leak above be fixed before new expansion joints are installed. Second, we provided the new expansion joints with a Butyl cover that would protect the joints if they were ever exposed to the caustic chemical again. When expansion joints are part of any application, it is essential to consider the environment outside the joint as well as what will be flowing through it. Environmental factors such as chemical attack, UV, and abrasion by fasteners or other equipment should part of the design.
