### Chemical Compatibility Prevents Expansion Joint Failure in a Reclaimed Water Facility Ventilation System

Holz Rubber Company engineered a custom rubber expansion joint for a ventilation system handling oil-saturated process air at a reclaimed water treatment facility.

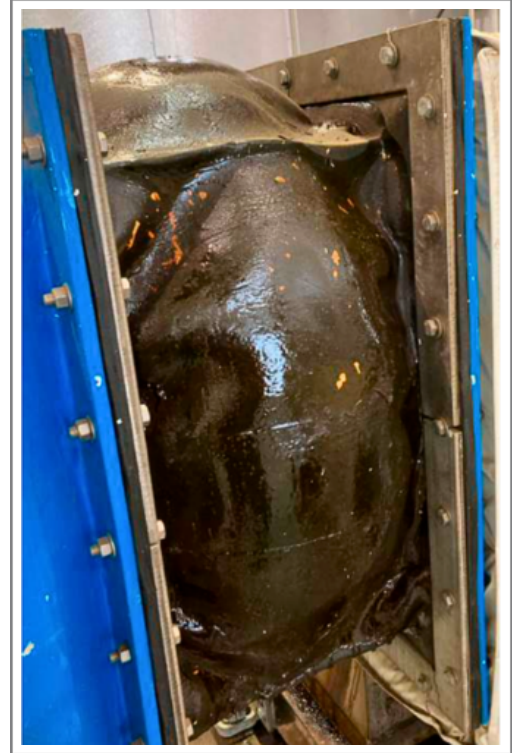
Facility personnel reported that a flue duct rubber expansion joint was leaking during normal operation. A system evaluation determined that the tube (gas-side) material used in the existing expansion joint was chemically incompatible with the petroleum-based oil present in the ventilation system.

As the incompatible elastomer was continuously exposed to the process media, the rubber began to deteriorate internally, allowing oil to penetrate the body of the expansion joint.

- Swelling of the rubber bellows
- Loss of structural integrity
- Oil saturation throughout the expansion joint body
- Oil weeping through the outer cover
- Leakage onto the floor below the ductwork, creating an avoidable safety hazard

The expansion joint had not failed because of age or excessive movement—it failed because the wrong elastomer had been selected for the application.

Rather than duplicating the failed expansion joint, Holz engineered a custom replacement utilizing:

- A Nitrile (Buna-N) tube for exceptional resistance to petroleum-based oils
- A durable Neoprene cover for outstanding weather, ozone, and environmental resistance
- Materials specifically selected for the facility's operating environment

Because Nitrile elastomers offer excellent compatibility with petroleum-based products, the new expansion joint was designed to provide significantly longer service life while preventing internal deterioration and oil migration through the joint body.
